KARL F. ACIMOVIC, P.E. & L.S.
CONSULTING ENGINEER

March 21, 2023

Re: Drainage Issue in the Area of 16 – 32 Lake View Drive
Lake Bunggee District

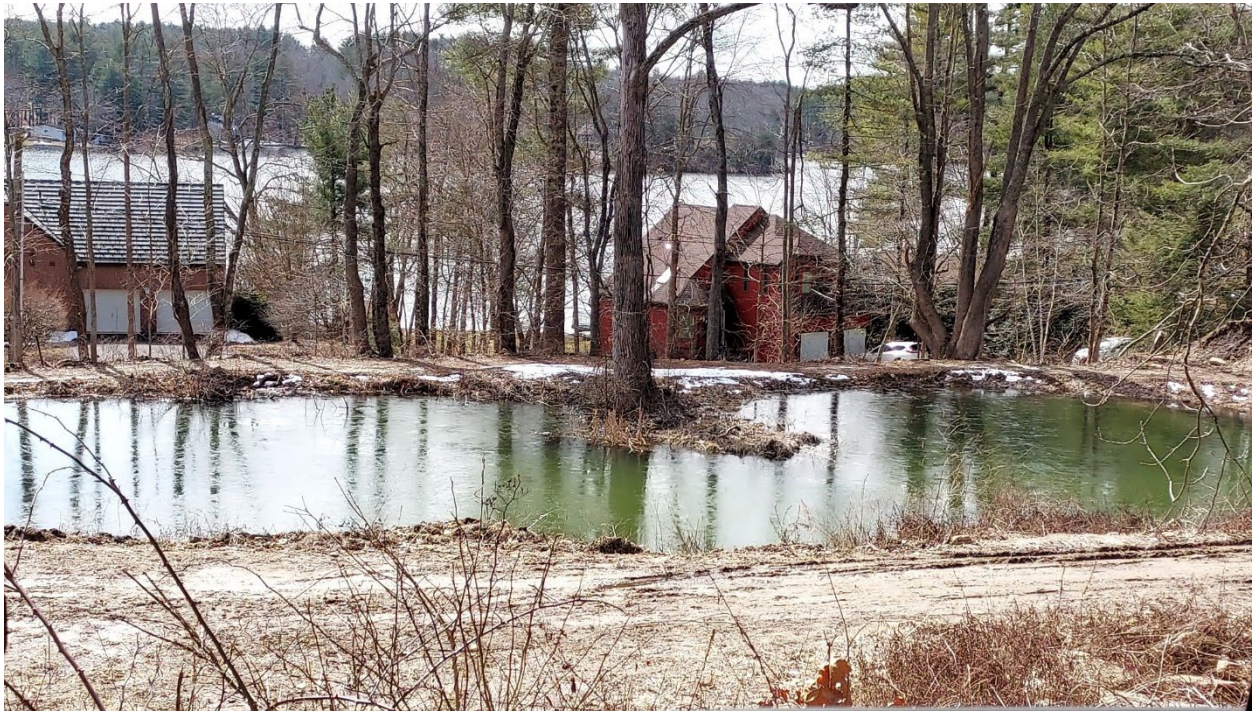
Photo 1 – The pond as seen from Bungay Hill Road, looking south toward Lake Bungee.

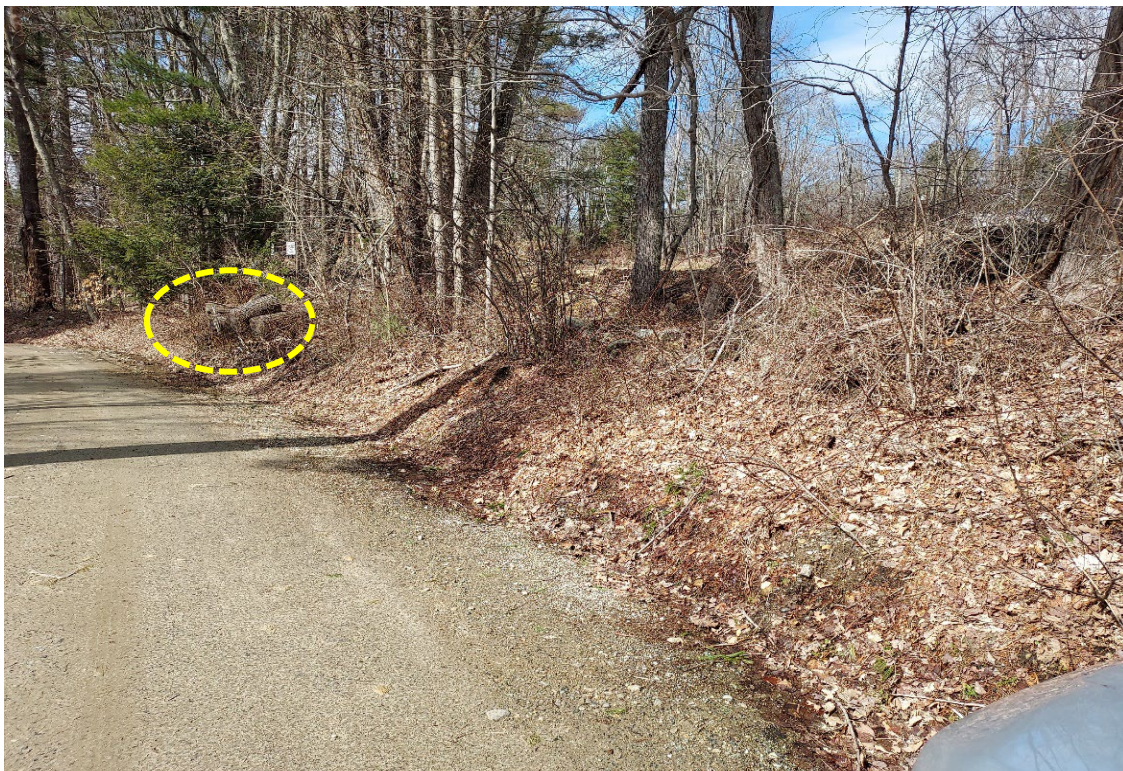
Photo 2 – Looking westerly along Lake View Drive. The pond is atop the embankment in the right of the photo. The circled area points out the location of the sole outlet pipe and the seepage area noted in the following photo.

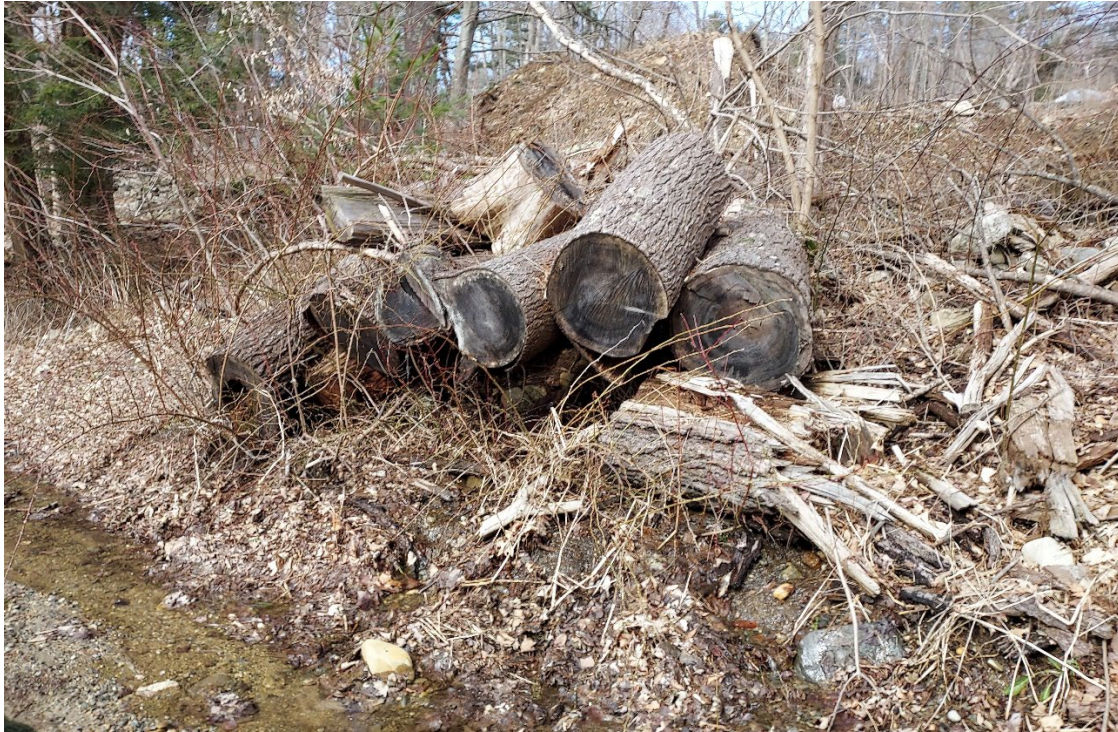
There is one small outlet pipe that was visible at the time of inspection, near the top of the slope, discharging a small amount of water. However, the majority of flow at the gutter line of the road was emanating from and through the approximate center of the embankment in an area covered by dense brush, cut tree trunk sections and varied pieces of cut wood and bark. This is an unstable situation which, during a strong or severe storm situation could easily result in slope failure (e.g., a landslide) through erosion and sloughing, with the resultant blockage of the roadway and potential movement of earth materials onto adjacent properties and / or flooding due to a sudden release of the impoundment. You also informed me that during a heavy rain period during the beginning of the week, flow emanated through the embankment not only in the area seen this day, but through a longer portion of the roadside slope.

Photo 3 – The outlet seepage area pointed out in the previous photo. The seepage extends over an approximate 6-foot width emanating from under the pile of logs.

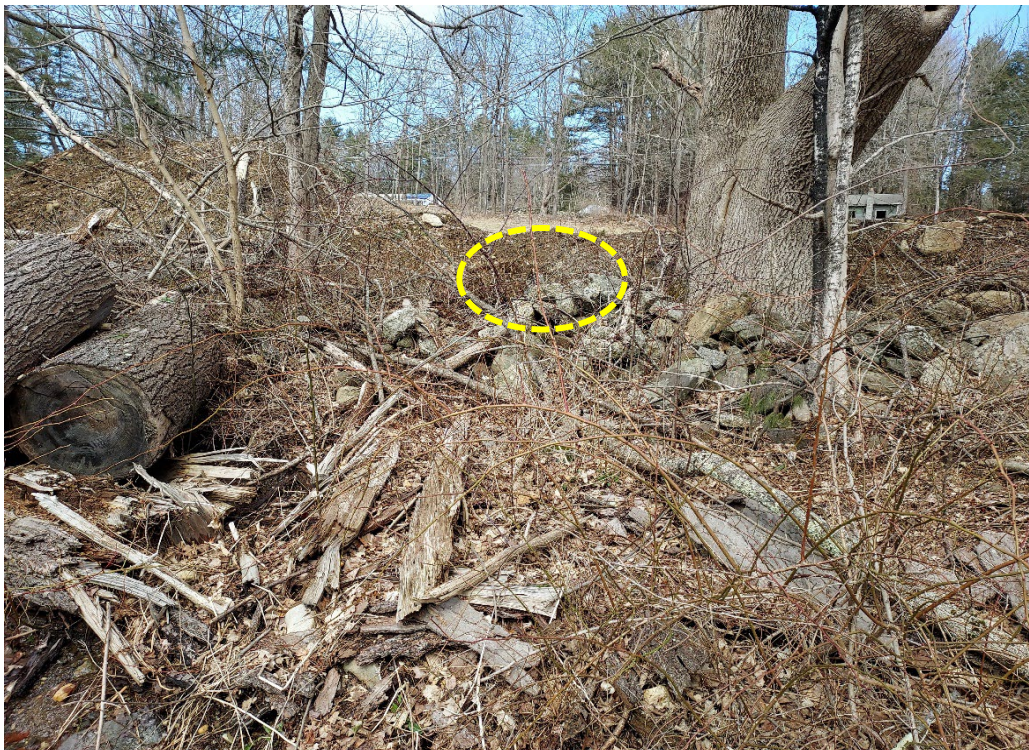
Photo 4 – The location of a small outlet pipe within the exposed soil berm atop the embankment.

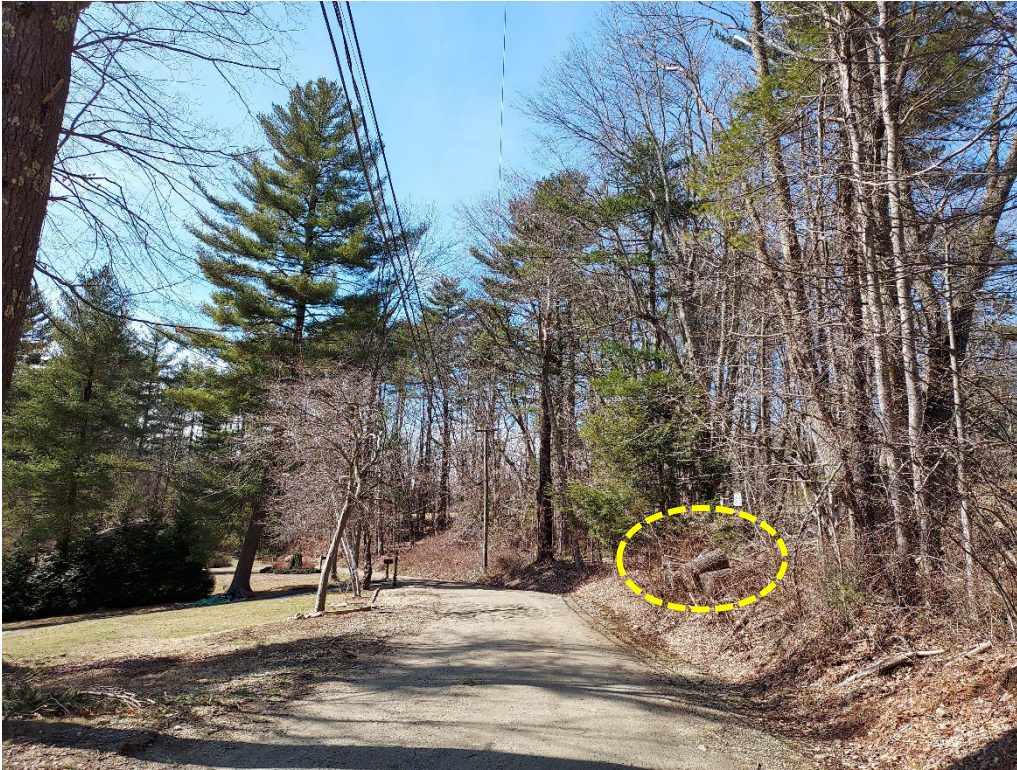
Note that when compared to issues with regard to dam embankments, slopes with improper zoning of soils and without underdrainage that become saturated during a storm, can not only slough and erode the embankment, but can also result in the toppling of the many trees in the area. When overturned, these trees will take out a significant root base, resulting in an opening of the embankment with a resultant dynamic wave moving downstream. In this case, any trees that drop toward the road will fall across utility wires running along the road.

Photo 5 – The same viewpoint as noted in Photo 2, showing the tall trees noted in the previous narrative and the utility lines along the road. The circle area once again represents the seepage outflow area shown in the previous photos.
