PROPERTY SURVEY  
 PREPARED FOR  
**LAURA V. MONAHAN**  
 LAKE VIEW DRIVE & BUNGAY HILL ROAD  
 WOODSTOCK, CONNECTICUT

**RE: Inspection of pond Excavation  
Bungay Hill Road & Lake View Drive**

Re: Drainage Issue at Lake View Drive  
Lake Bunggee District

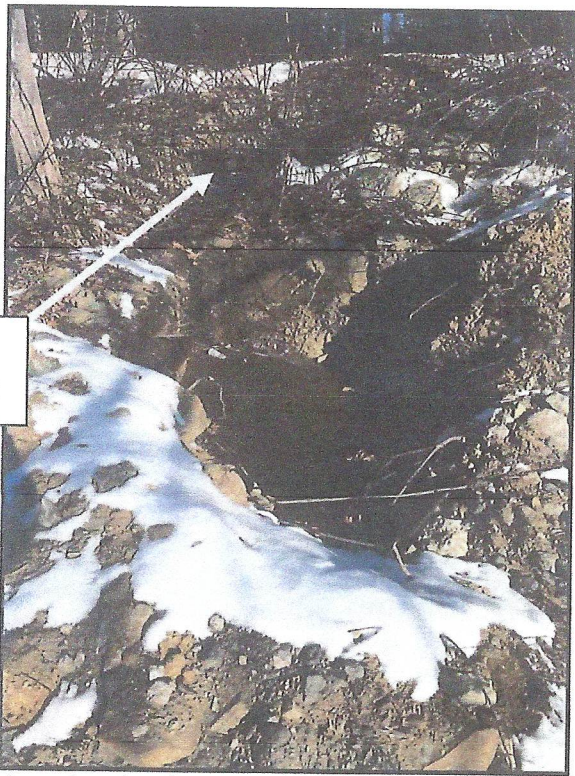
The drainage pipe from Bungay Hill Road onto your property is partially hidden and set back into the stone wall along the northern side of your property. It appears to be a 12" pipe and discharges to an embankment on your and into an excavation preceding the on-site swale which has created somewhat of a plunge pool. From the plunge pool, the swale flows south toward the pond where you have installed a 12" concrete pipe within the embankment. Photos 1 & 2 show the outlet pipe from Bungay Hill Road and the on-site swale that flows to the pond. It was noted that the plunge pool has a gravelly bottom

Photo 1: outlet pipe from Bungee Hill & “plunge pool”

4. The outlet from the pipe at Bungee Hill Road should also be reinforced with modified riprap. Since this is a pipe from a Town discharge, it would be reasonable to request that the Town of Woodstock public works department conduct this work or you are compensated for the time and materials to complete the work.

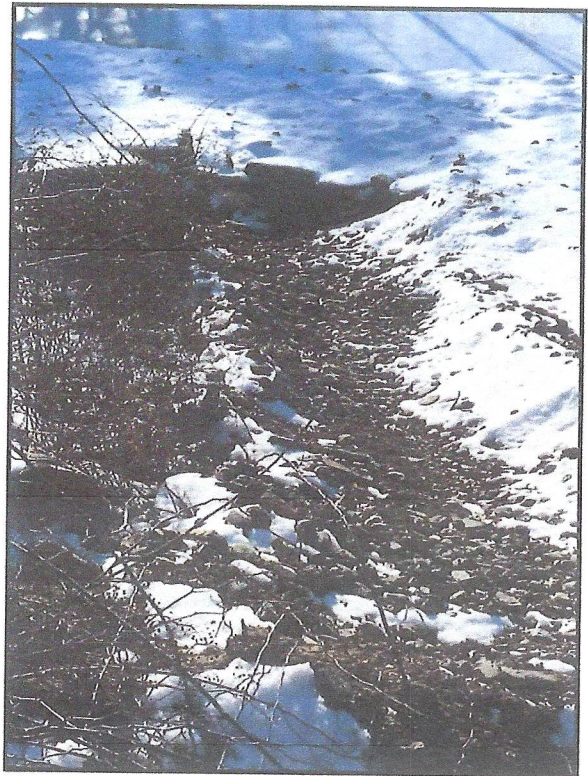
Photo 2: Swale to pond from Bungee Hill drainage

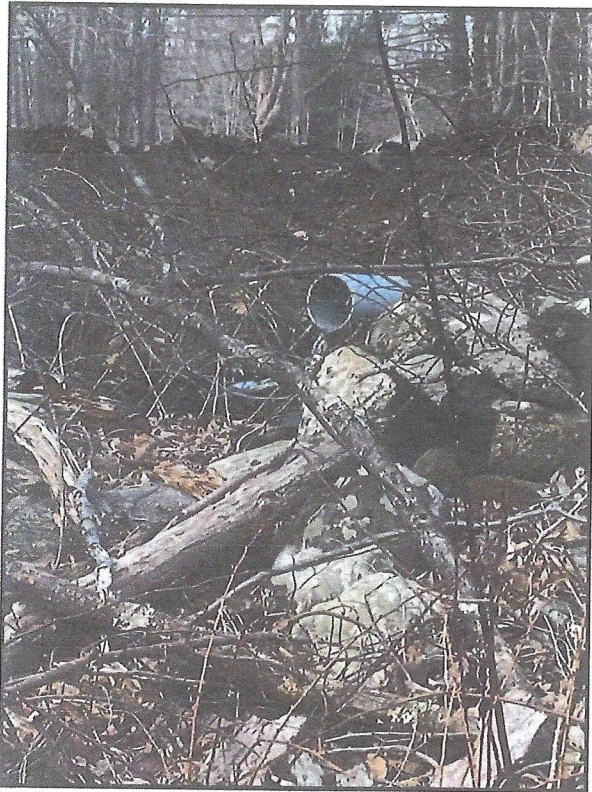
Based upon inspection of on-site conditions, it appears that overflow from the pond prior to it being enlarged discharged to a slope along the northern side of Lake View Drive and ultimately to a roadside swale. For the modified pond, the level is controlled by an 8" outlet pipe that is installed in the southwest embankment. This pipe drains to the same roadside swale. This 8" PVC pipe controls the level of the pond and discharges to the northern slope adjacent to Pond View Road. Ultimately, all discharge from this pipe flows down-gradient to a roadside swale and to a low point approximately 300' west where it then crosses under the road to a swale that flows to Lake Bungee. Photos 3 & 4 show the outlet pipe from the pond and the swale along the northern side of Lake View Drive.

Photo 3: Outlet pipe from pond on Lake View

1. The cross-sectional area of the 12" pipe from Bungee Hill Road and at the end of the swale is 113 square inches and the 8" outlet pipe from the pond is slightly over 50 square inches. In order to ensure that the pond level is continuous, the 18" of freeboard is maintained, and that in and out flow rates are consistent, a second 8" outlet pipe from the pond should be installed on the eastern end that discharges to the embankment adjacent to and up gradient from the existing catch basin.

3. The embankment along Lake View Drive should be cleared of debris at the pipe discharge points and riprap outlet protection should be installed. I would recommend installation of a filter fabric under the riprap which should consist of 6"-8" angular stone ("modified" riprap per CTDOT specifications). Extend the riprap protection full length down the slope to the existing roadside swale and catch basin.

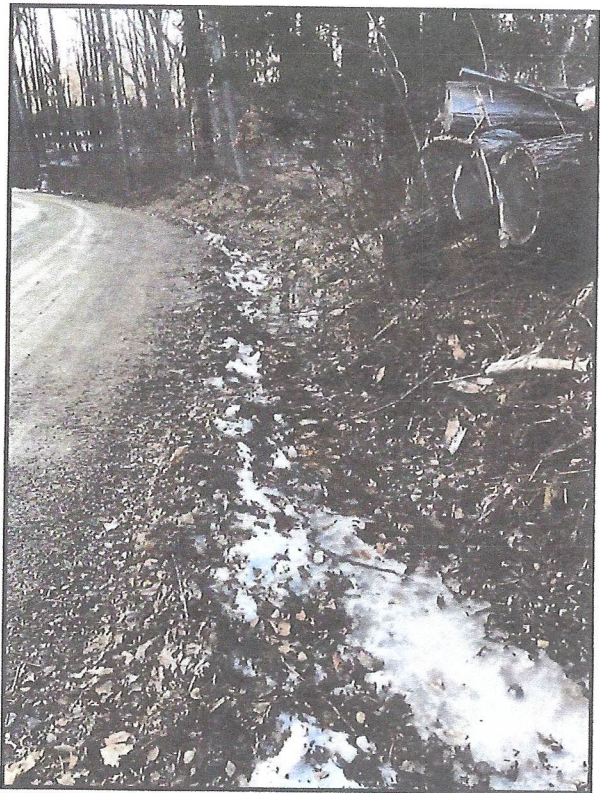
Photo 2: Swale along northern side of Lake View

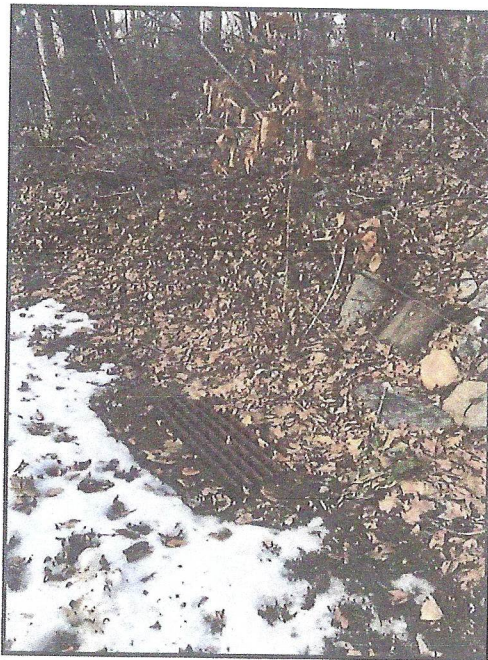
There is a roadside catch basin located approximately 150' to the east from the discharge point and it is my understanding that there has been discussion of directing the outlet from the pond to this catch basin. Photo 5 shows this catch basin and the option to direct water from the pond to this basin is discussed further in this report under our recommendations.

Photo 5: Catch basin along Lake View Drive

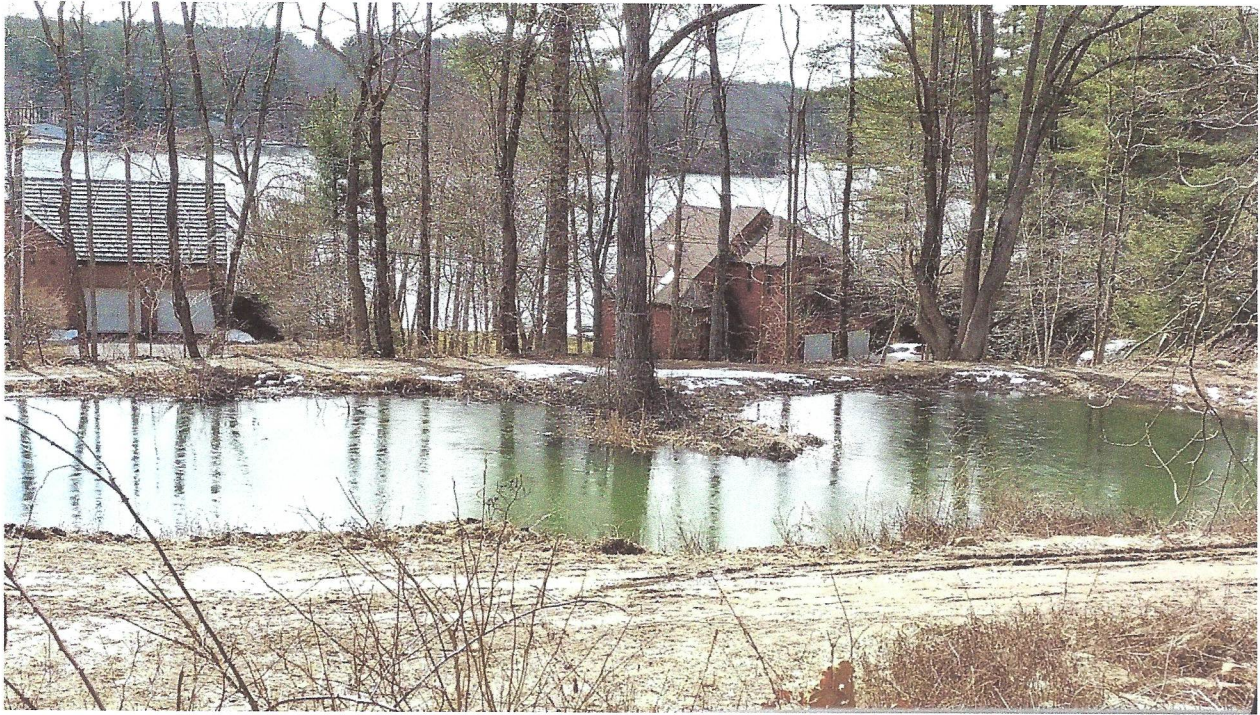
Photo 1 – The pond as seen from Bungay Hill Road, looking south toward Lake Bunggee.

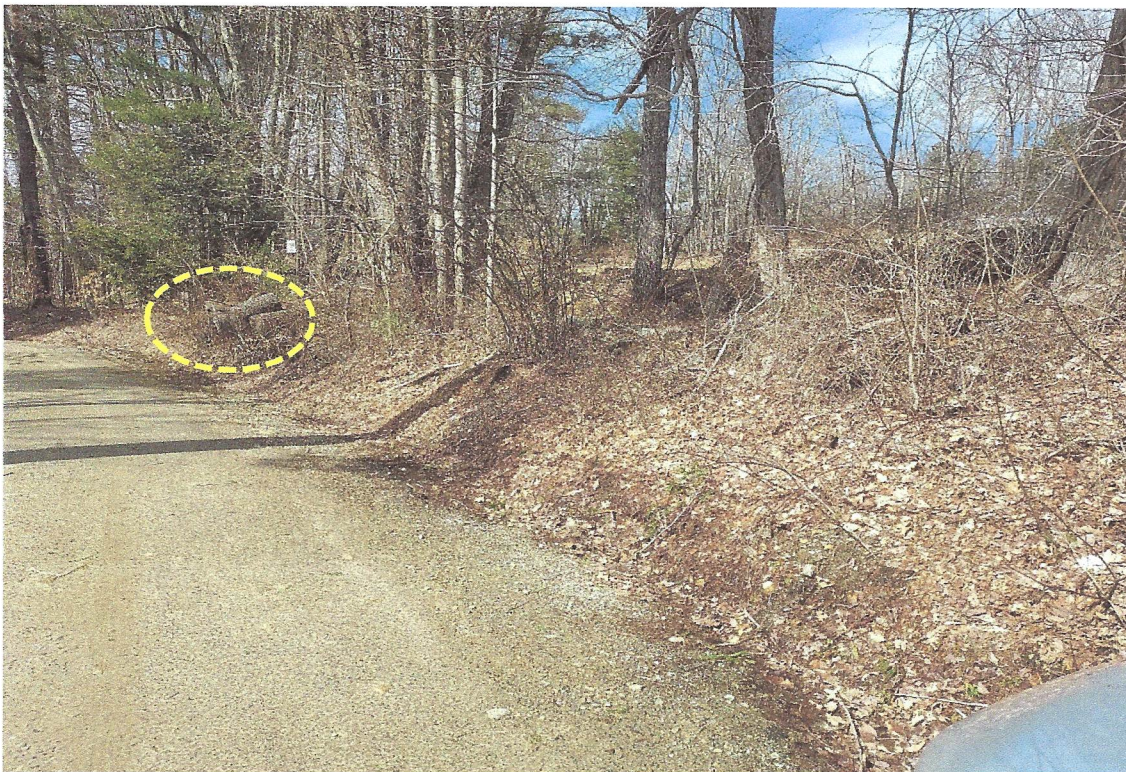
As noted in the previous communication, the area in question along Lake View Drive lay just downstream of a steep slope with a small pond on top of the adjacent embankment. The slope and embankment essentially act as a dam, holding back the water impounded by the pond. The embankment represents a sheer drop (1H:1V or less in some cases), is covered with brush and large trees, has an unstable and exposed soil berm along its crest, and is saturated, leaking and seeping throughout the slope area adjacent to the pond and the road.

Photo 2 – Looking westerly along Lake View Drive. The pond is atop the embankment in the right of the photo. The circled area points out the location of the sole outlet pipe and the seepage area noted in the following photo.

If the pond atop the embankment is to remain, I would highly recommend that it be properly designed and passed through a thorough permitting process, subsequently supervised by qualified consultants or experts knowledgeable in the required disciplines involved. In any case, this will require a proper drainage system from the pond and its incoming stream, as well as along the current gutter line on the north side of Lake View Drive. I would make reference to my correspondence of February 17, 2022 for further evaluations and insights.

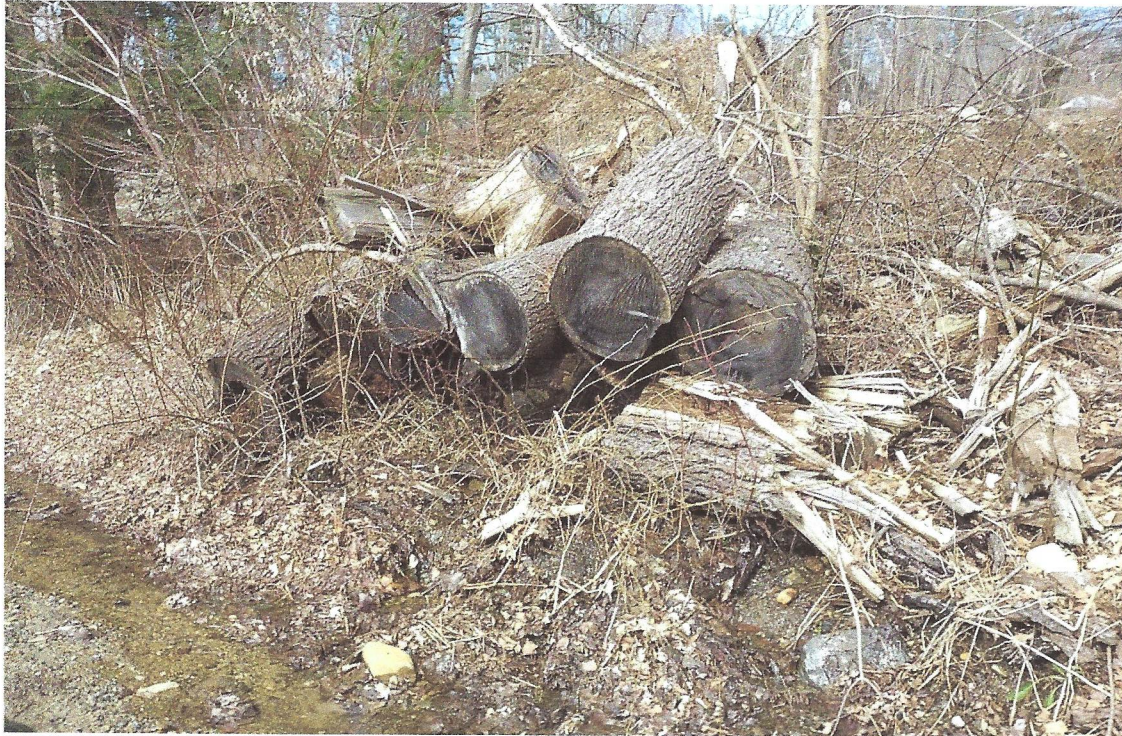
There is one small outlet pipe that was visible at the time of inspection, near the top of the slope, discharging a small amount of water. However, the majority of flow at the gutter line of the road was emanating from and through the approximate center of the embankment in an area covered by dense brush, cut tree trunk sections and varied pieces of cut wood and bark. This is an unstable situation which, during a strong or severe storm situation could easily result in slope failure (e.g., a landslide) through erosion and sloughing, with the resultant blockage of the roadway and potential movement of earth materials onto adjacent properties and / or flooding due to a sudden release of the impoundment. You also informed me that during a heavy rain period during the beginning of the week, flow emanated through the embankment not only in the area seen this day, but through a longer portion of the roadside slope.

Photo 3 – The outlet seepage area pointed out in the previous photo. The seepage extends over an approximate 6-foot width emanating from under the pile of logs.

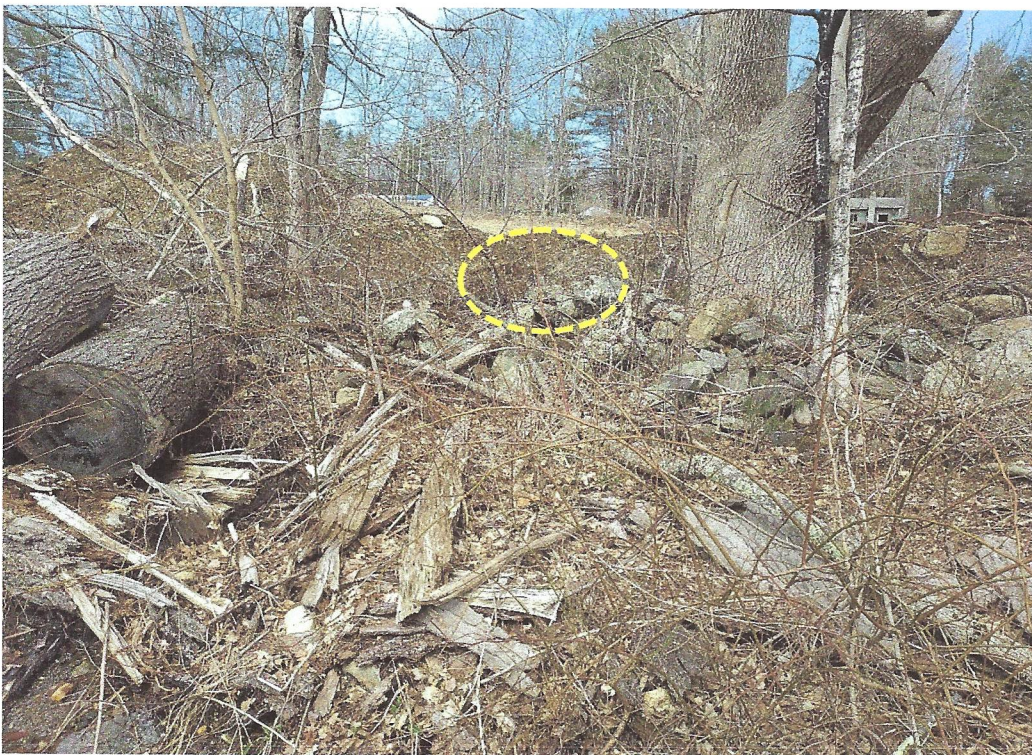
Photo 4 – The location of a small outlet pipe within the exposed soil berm atop the embankment.

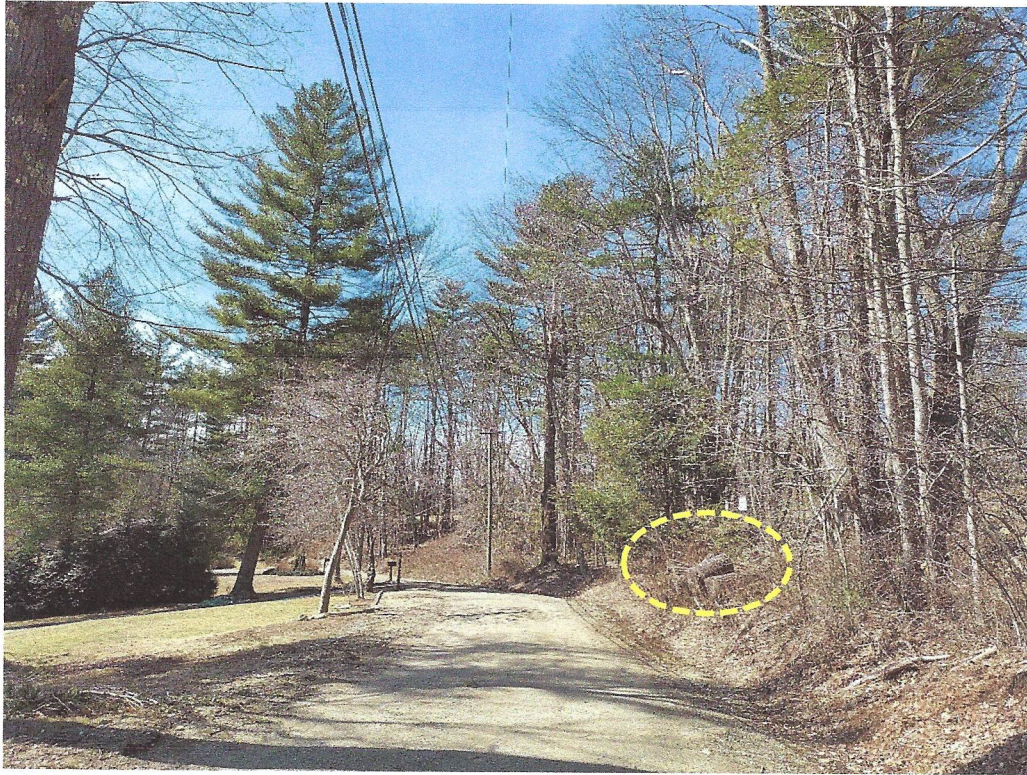
Note that when compared to issues with regard to dam embankments, slopes with improper zoning of soils and without underdrainage that become saturated during a storm, can not only slough and erode the embankment, but can also result in the toppling of the many trees in the area. When overturned, these trees will take out a significant root base, resulting in an opening of the embankment with a resultant dynamic wave moving downstream. In this case, any trees that drop toward the road will fall across utility wires running along the road.

Photo 5 – The same viewpoint as noted in Photo 2, showing the tall trees noted in the previous narrative and the utility lines along the road. The circle area once again represents the seepage outflow area shown in the previous photos.

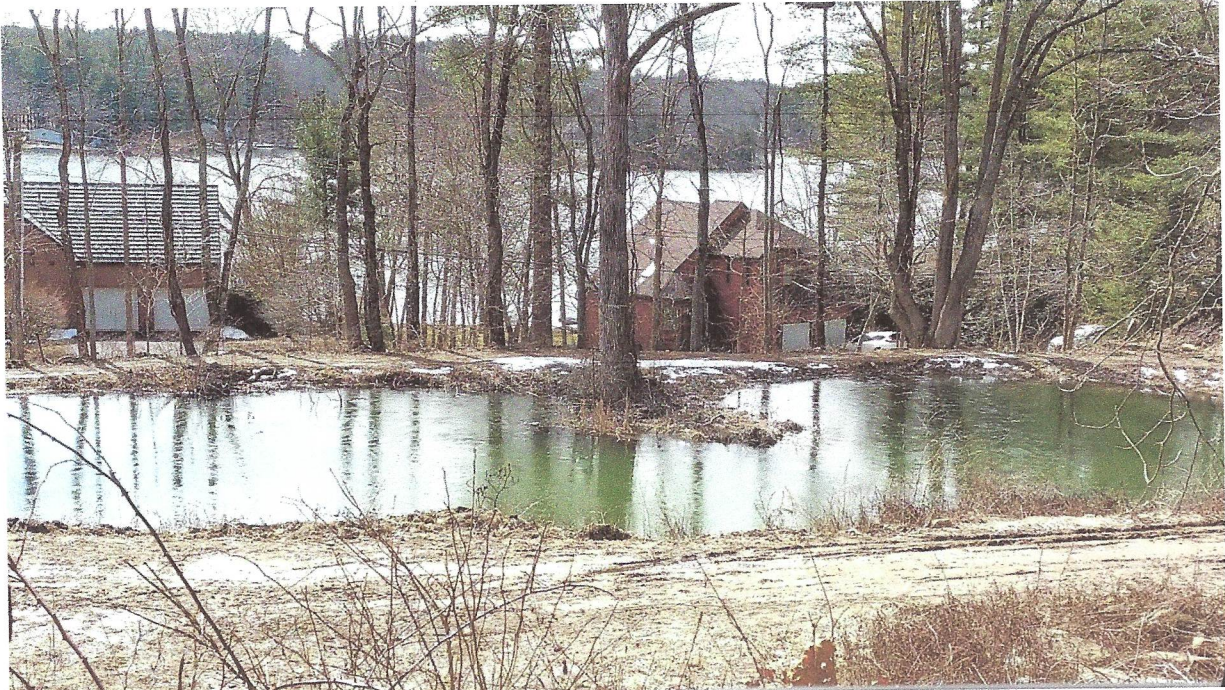
Photo 1 – The pond as seen from Bungay Hill Road, looking south toward Lake Bungee.

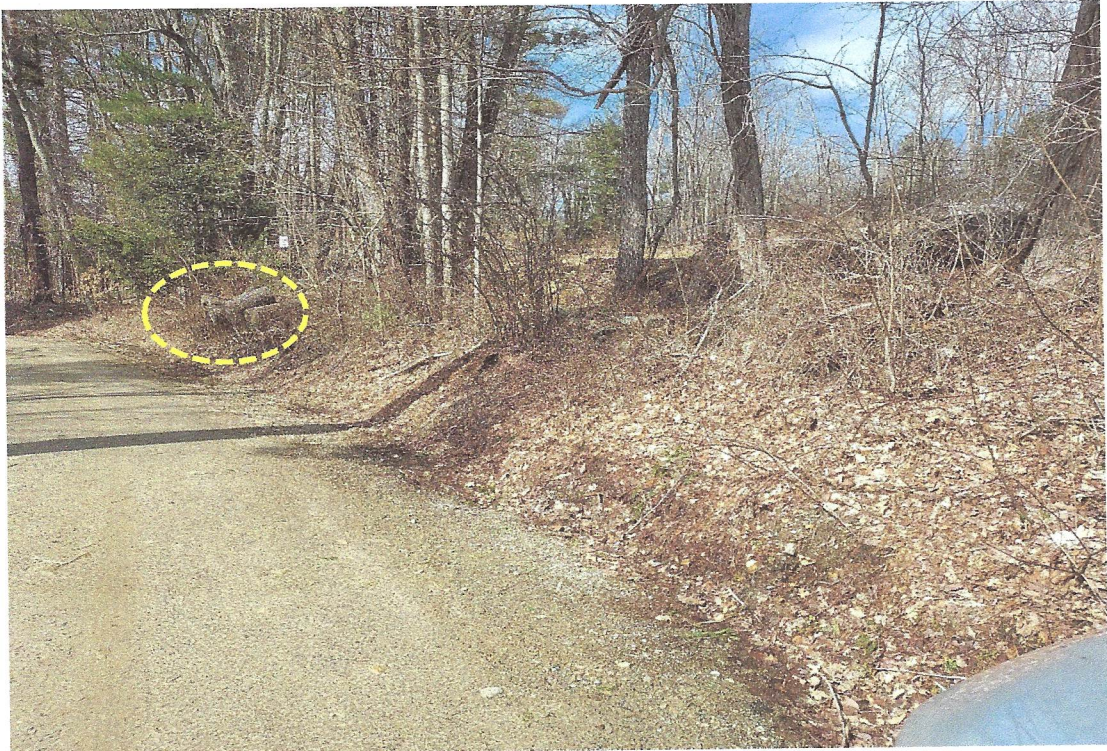
As noted in the previous communication, the area in question along Lake View Drive lay just downstream of a steep slope with a small pond on top of the adjacent embankment. The slope and embankment essentially act as a dam, holding back the water impounded by the pond. The embankment represents a sheer drop (1H:1V or less in some cases), is covered with brush and large trees, has an unstable and exposed soil berm along its crest, and is saturated, leaking and seeping throughout the slope area adjacent to the pond and the road.

Photo 2 – Looking westerly along Lake View Drive. The pond is atop the embankment in the right of the photo. The circled area points out the location of the sole outlet pipe and the seepage area noted in the following photo.

If the pond atop the embankment is to remain, I would highly recommend that it be properly designed and passed through a thorough permitting process, subsequently supervised by qualified consultants or experts knowledgeable in the required disciplines involved. In any case, this will require a proper drainage system from the pond and its incoming stream, as well as along the current gutter line on the north side of Lake View Drive. I would make reference to my correspondence of February 17, 2022 for further evaluations and insights.

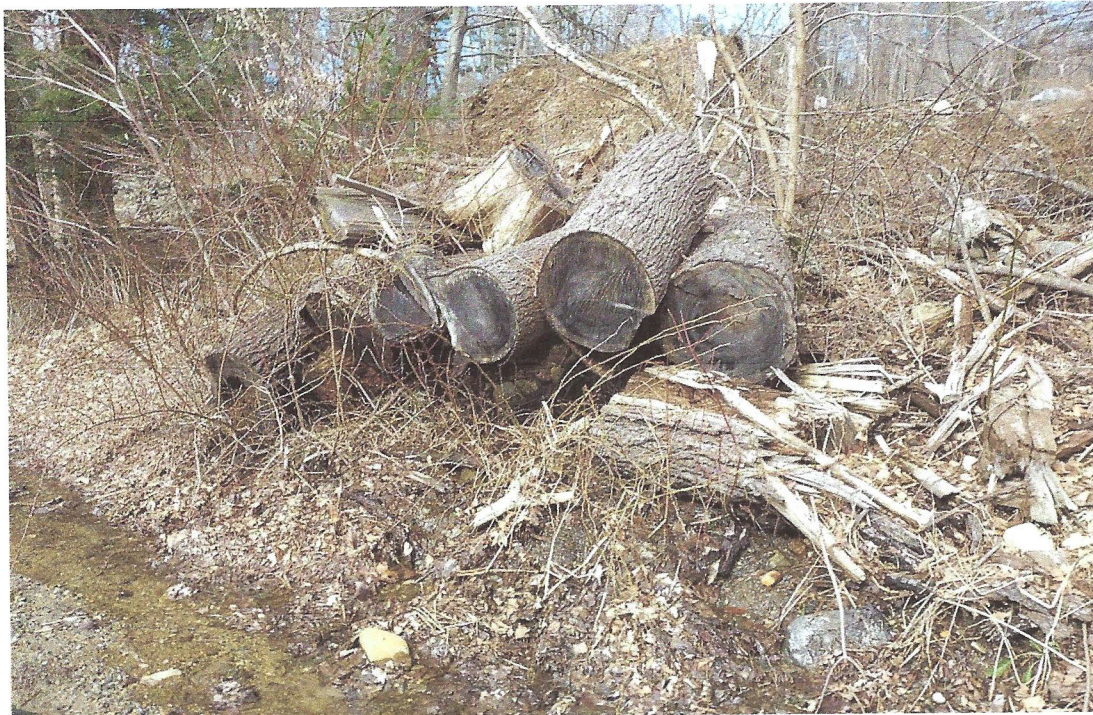
There is one small outlet pipe that was visible at the time of inspection, near the top of the slope, discharging a small amount of water. However, the majority of flow at the gutter line of the road was emanating from and through the approximate center of the embankment in an area covered by dense brush, cut tree trunk sections and varied pieces of cut wood and bark. This is an unstable situation which, during a strong or severe storm situation could easily result in slope failure (e.g., a landslide) through erosion and sloughing, with the resultant blockage of the roadway and potential movement of earth materials onto adjacent properties and / or flooding due to a sudden release of the impoundment. You also informed me that during a heavy rain period during the beginning of the week, flow emanated through the embankment not only in the area seen this day, but through a longer portion of the roadside slope.

Photo 3 – The outlet seepage area pointed out in the previous photo. The seepage extends over an approximate 6-foot width emanating from under the pile of logs.

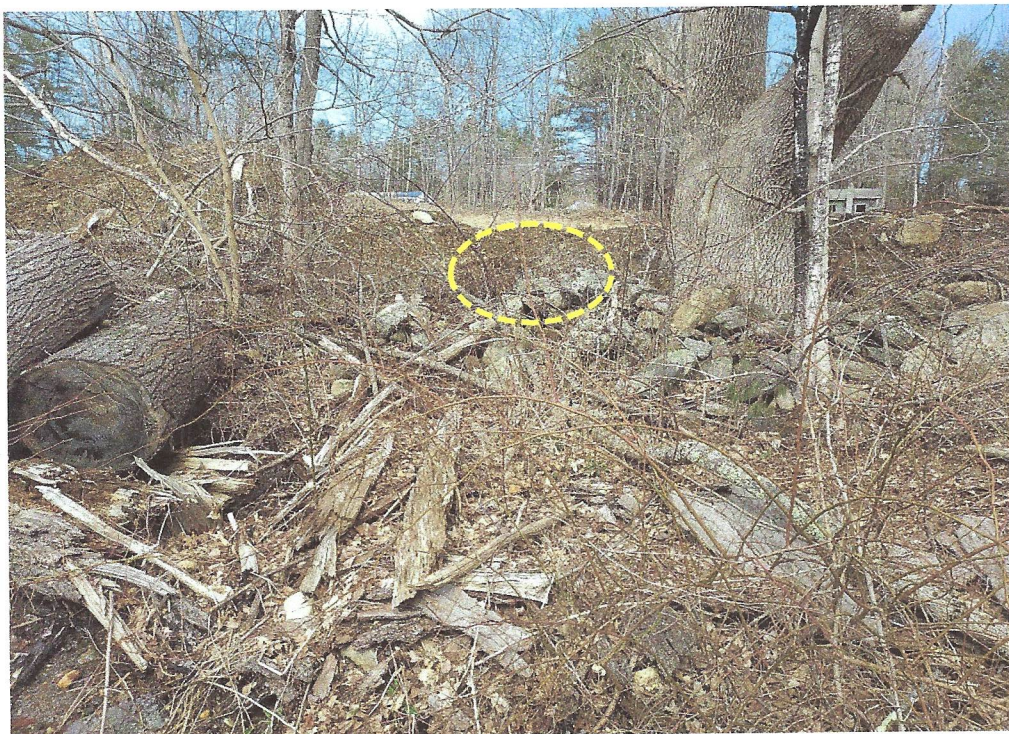
Photo 4 – The location of a small outlet pipe within the exposed soil berm atop the embankment.

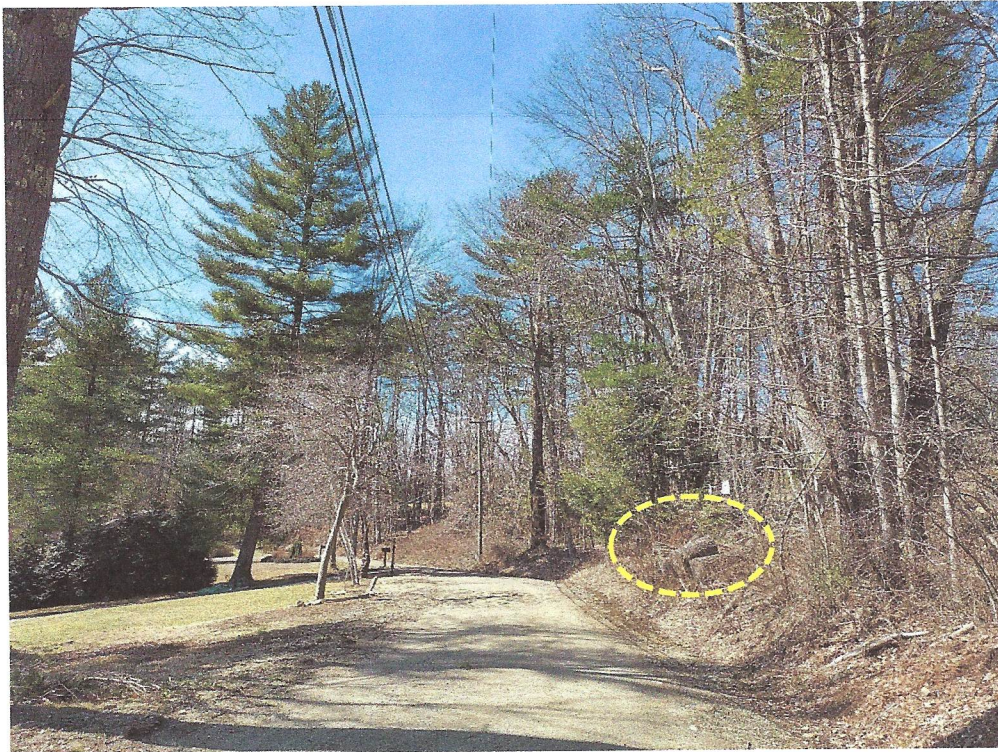
Note that when compared to issues with regard to dam embankments, slopes with improper zoning of soils and without underdrainage that become saturated during a storm, can not only slough and erode the embankment, but can also result in the toppling of the many trees in the area. When overturned, these trees will take out a significant root base, resulting in an opening of the embankment with a resultant dynamic wave moving downstream. In this case, any trees that drop toward the road will fall across utility wires running along the road.

Photo 5 – The same viewpoint as noted in Photo 2, showing the tall trees noted in the previous narrative and the utility lines along the road. The circle area once again represents the seepage outflow area shown in the previous photos.
